# Service-Information Motorcycle

Group: 11  
Engine

January, 1993  
11 055 93  
(2575)

## Vibrations - K-1, K1100LT and K100RS 16-valve

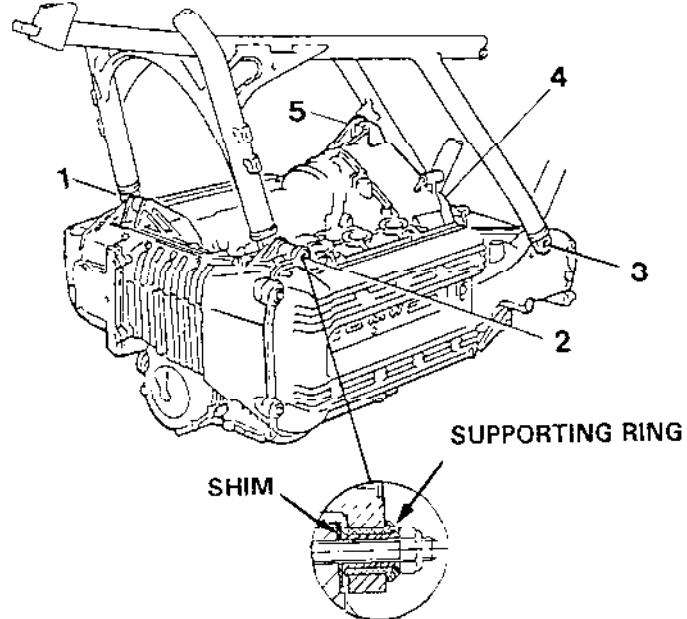
The engine must be secured to the frame without stress. Use the following procedure to check engine to frame mounting.

#### A. K1 Rigid Front Engine Mounts

- A.1. Screw in all 5 bolts loosely by hand, but not as far as the bolt head.
- A.2. Tighten at the front right and rear right (bolting points 1 and 4).

A.3. Shim the bolt at the intermediate flange and tighten (5).

A.4. Tighten at the front left and rear left (2 and 3).

Tightening torque 45 Nm (32.5 ft/lb)
