Service-Information Motorcycle

July 1986
32 005 86
(2224)

Recall Campaign 86V-80: Inspection/Replacement of K-Model Throttle Cables

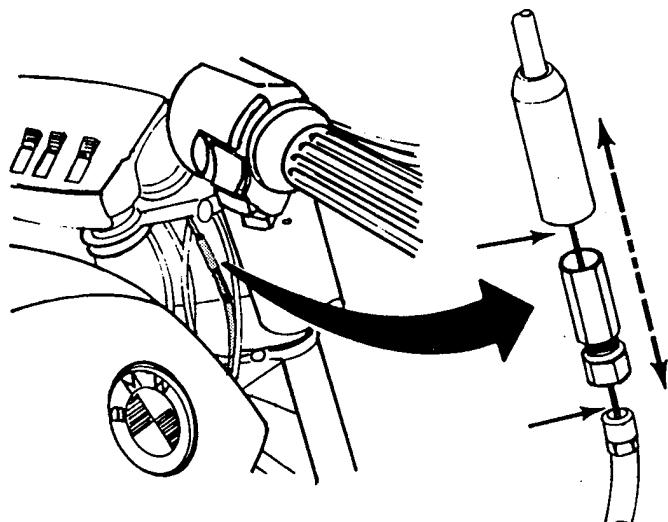
Visually inspect the lower throttle cable at the throttle body. Inspect the upper and center section of the cable (see Fig. 1). Important: Do not bend or twist the throttle cable when checking the upper and center sections.

Inspect each throttle cable support-to-throttle cam alignment or look for a visible bend or kink in the braided cable. If support-to-throttle cam misalignment is detected, or if the throttle cable shows any signs of chafing or wear at the positions shown in Fig. 1 or Fig. 2, replace the cable and cable support (see Fig. 3). Follow throttle cable replacement procedures below.

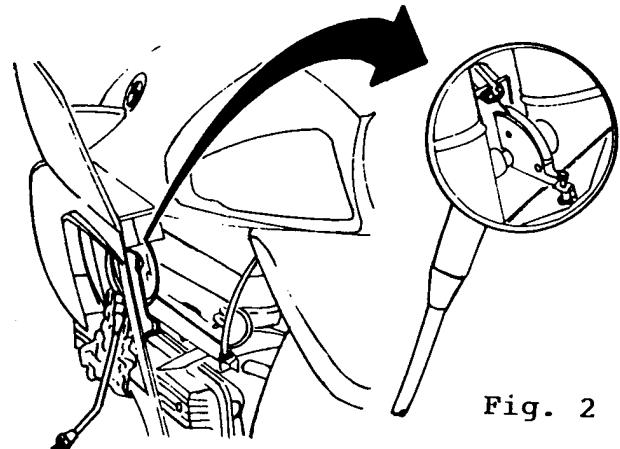
Fig. 2

Remove the left knee pad, place a mirror in the louvers and support it with a rag (see Fig. 2). Visually inspect the lower throttle cable at the throttle body, using a flashlight, while operating the throttle twist grip. Inspect the upper and center sections. Important: Do not bend or twist the throttle cable when checking the upper and center sections.

Model: K100RT Remove the left knee pad and air deflector. Place a mirror in the louvers and support it with a rag (see Fig. 2). Important: Do not bend or twist the throttle cable when checking the upper and center section.

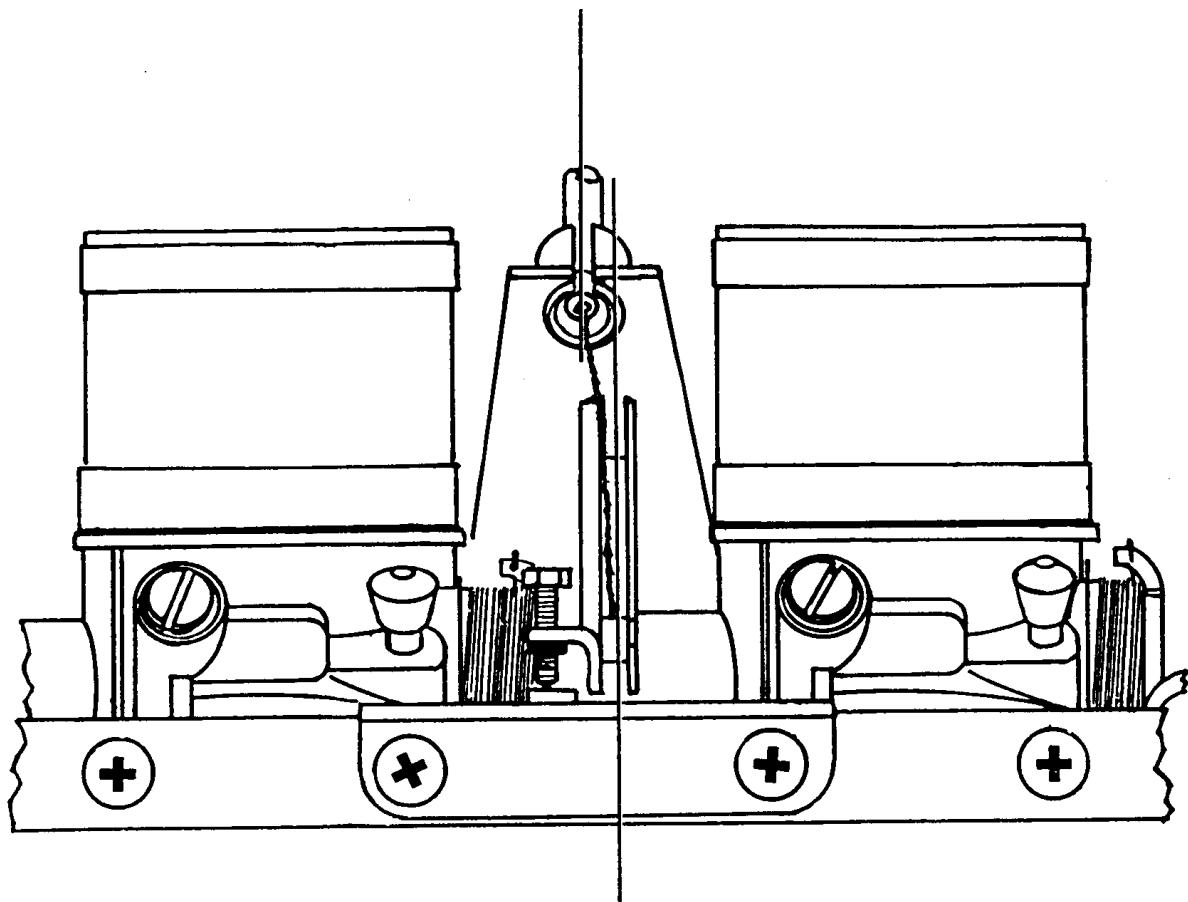
Fig. 3:

The potential defect involves the throttle cable of the vehicles affected. During production, the cable of a small number of potentially affected vehicles may have been bent during installation (see Note below). This could occur due to misalignment between the throttle cable support (attached to the throttle body assembly) and the cam attached to the throttle valve shaft due to those components exceeding manufacturing tolerances. Since the cable is routed from the support to the cam, as shown in the attached illustration, a bend or kink in the braided metal cable could result. In addition, bending of the cable could also occur at either or both of the two points shown in the attached illustration where the cable exits from the adjustment hardware. In such cases, chafing between the braided throttle cable and the outer sleeve would result in a moderate but detectable increase in throttle operating effort.

throttle cable support and
throttle cam
(illustrated to show
misalignment)

Inspect for visible bending, kinking or chafing of the braided cable and check for impaired throttle cable operation. If either or both of the foregoing conditions are found, replace the cable and cable support (see Fig. 3). Follow throttle cable replacement procedures below.

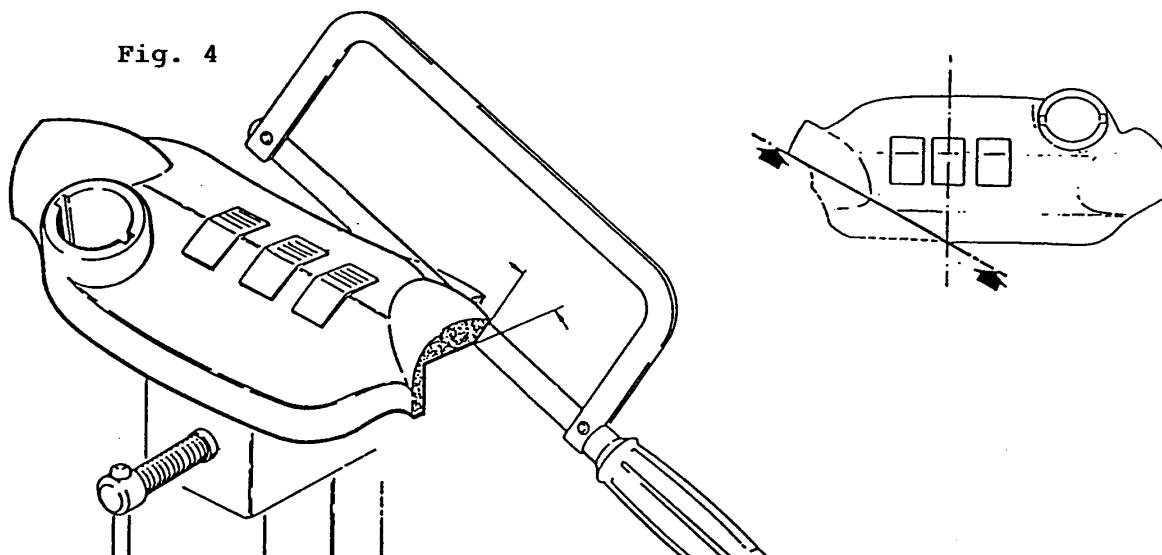
As explained on Page 5 of this Service Information bulletin, the handlebar pad requires modification to avoid bends or kinks when the new throttle cable is installed.

| -- | Replace air cleaner housing, air intake snorkel and fuel tank. |
-
| -- | Modify handlebar pad (see Fig. 4) and attach it. |

Using a metal cutting saw, make a straight line cut according to the drawing below. Smooth the cut edge with a fine file or grinding wheel. Touch up the cut area with black paint.
