Service-Information Motorcycle

Sealing the Combination Coolant/Oil Pump Assembly - K Models

This bulletin replaces S.I. #11 036 87 (2269), which should be discarded.

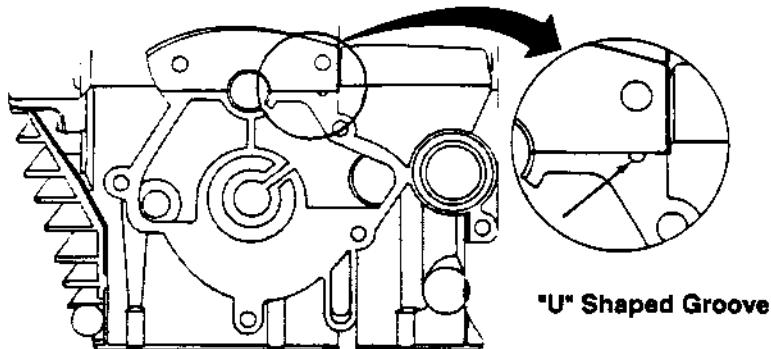
Fig. 1

Cause: 1. - The over-pressure relief hole may be blocked by sealant. (See Fig. 1).

1. - Remove the coolant/oil pump and clean the sealing surfaces. Use a suitable tool (wire probe) to ensure the U-shaped relief hole is not plugged with sealant.
- Use a flat sharpening stone on the pump and crank-case surface to highlight/remove any raised points on the sealing surfaces that may cause poor sealing.
- When re-fitting the coolant/oil pump make sure the sealing surfaces are clean and dry. Use BMW sealant 1209 - part no. 07 58 9 062 376 - making sure the sealant is applied to the outside perimeter in relation to the relief hole. Do not apply excessive sealant. (See Fig. 2)
