# Service-Information Motorcycle

Group: 16  
Fuel Tank  
and Lines

December, 1992  
16 017 92  
(2565)

## Fuel Tank Cap - All K-Models from 1986

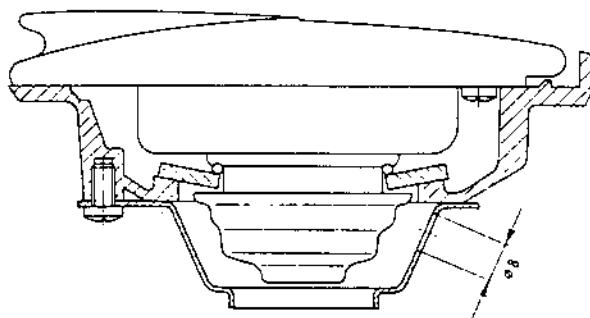
**Situation:** Since the introduction of the shed system in 1986, the fuel tank cap has had a smaller opening for the gas filler nozzle.

**Problem:** Due to the smaller opening, vapors cannot escape the tank and refueling to capacity is difficult.

**Remedy:** Remove the fuel cap assembly and enlarge the small 3.5 breather hole to 8mm (see drawing).

**Caution:** Do not attempt to enlarge the breather hole while the fuel cap is mounted to the tank as contaminants will fall into the tank.

**Always use a new gasket when replacing the cap.**
