# Service-Information Motorcycle

Clutch

21 006 89  
(2355)

## Oil Leak at the Clutch Push Rod Boot - R & K Models

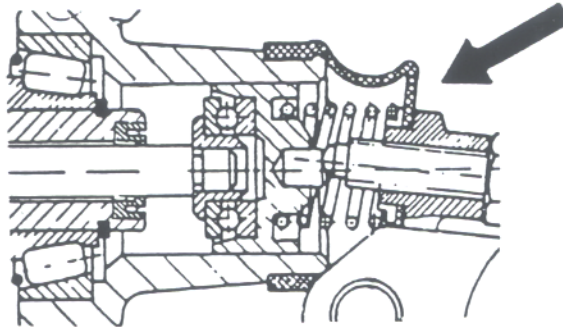
**Problem:** Gearbox oil leaking from the clutch push rod boot at the adjustment bolt.

**Cause:** Improper clutch adjustment. The coil spring cannot put enough pressure against the boot's sealing surface to contain the gear box oil when the clutch free-play is improperly adjusted. The greater the free-play, the further the sealing surface arcs back from the base of the spring.

**Remedy:** Adjust the clutch cable as described in the Rider's Manual or Workshop manual. It is extremely important to maintain the correct length of exposed cable at the gearbox clutch lever arm so that the coil spring under the push rod boot is at the proper tension.

**Note:** Most leaking boots can be corrected by cleaning the boot and seal surface, then re-installing and properly adjusting cable free-play.
