Service-Information Motorcycle

Group: 46
Frame

May 1995
46 047 95
(2673)
Page 1 of 3

Side Stand, all K Models, & R 1100 Models

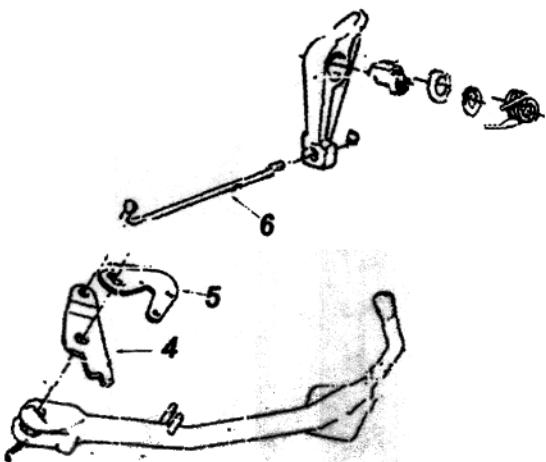
The above drawing is of the K 2 valve model, if after cleaning, lubricating, and adjusting it does not work correctly-check # 4, # 5, and # 6 for stretching and/or distortion. Correct as needed.

Note: If the side stand bolt has been loosened/removed, please ensure you use Loctite # 242 and torque to specification below:

K 2 valve	41 Nm	(30 Ft. Lb.)
K 4 valve	41 Nm	(30 Ft. Lb.)
R 1100	41 Nm	(30 Ft. Lb.)

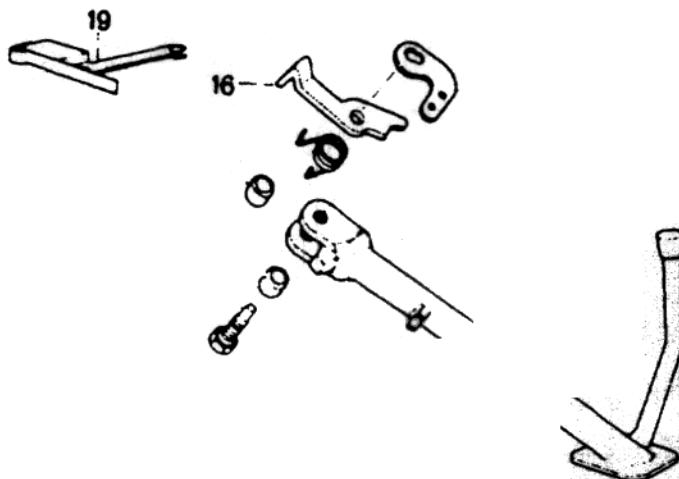
The above drawing is a K 4 valve model. If after cleaning, lubricating, and adjusting it does not work correctly - check # 16, and #19 for stretching and/or distortion. Correct as needed.

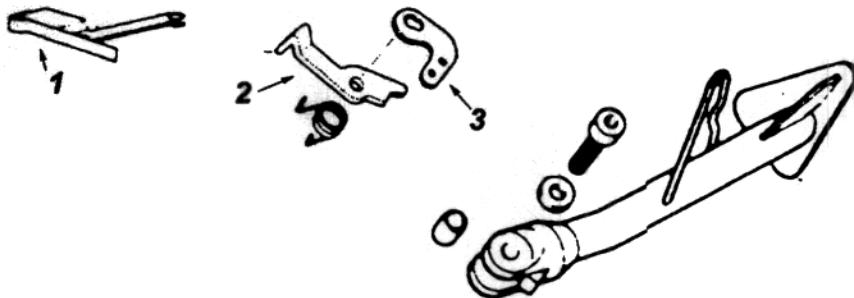
The above drawing is a R 1100 model. If after cleaning, lubricating, and adjusting it does not work correctly-check # 1, # 2, and # 3 for stretching and/or distortion. Correct as needed.
