# Service-Information Motorcycle

Group: 21  
Clutch

December, 1986  
21 005 86  
(2232)

## Clutch Spline Failure - All K Models

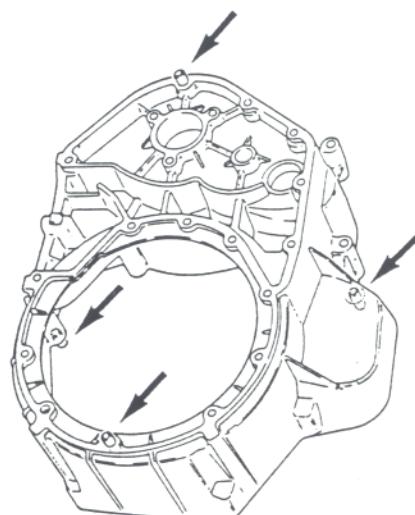
On all K models exact alignment is obtained by two locating dowels between the engine block and bell housing, and also between the gearbox and the bell housing.

If you suspect clutch damage or premature spline wear, please check that the locating sleeves are installed in the proper places.
