Refreshing the K75 part 1: Fuel pump damper

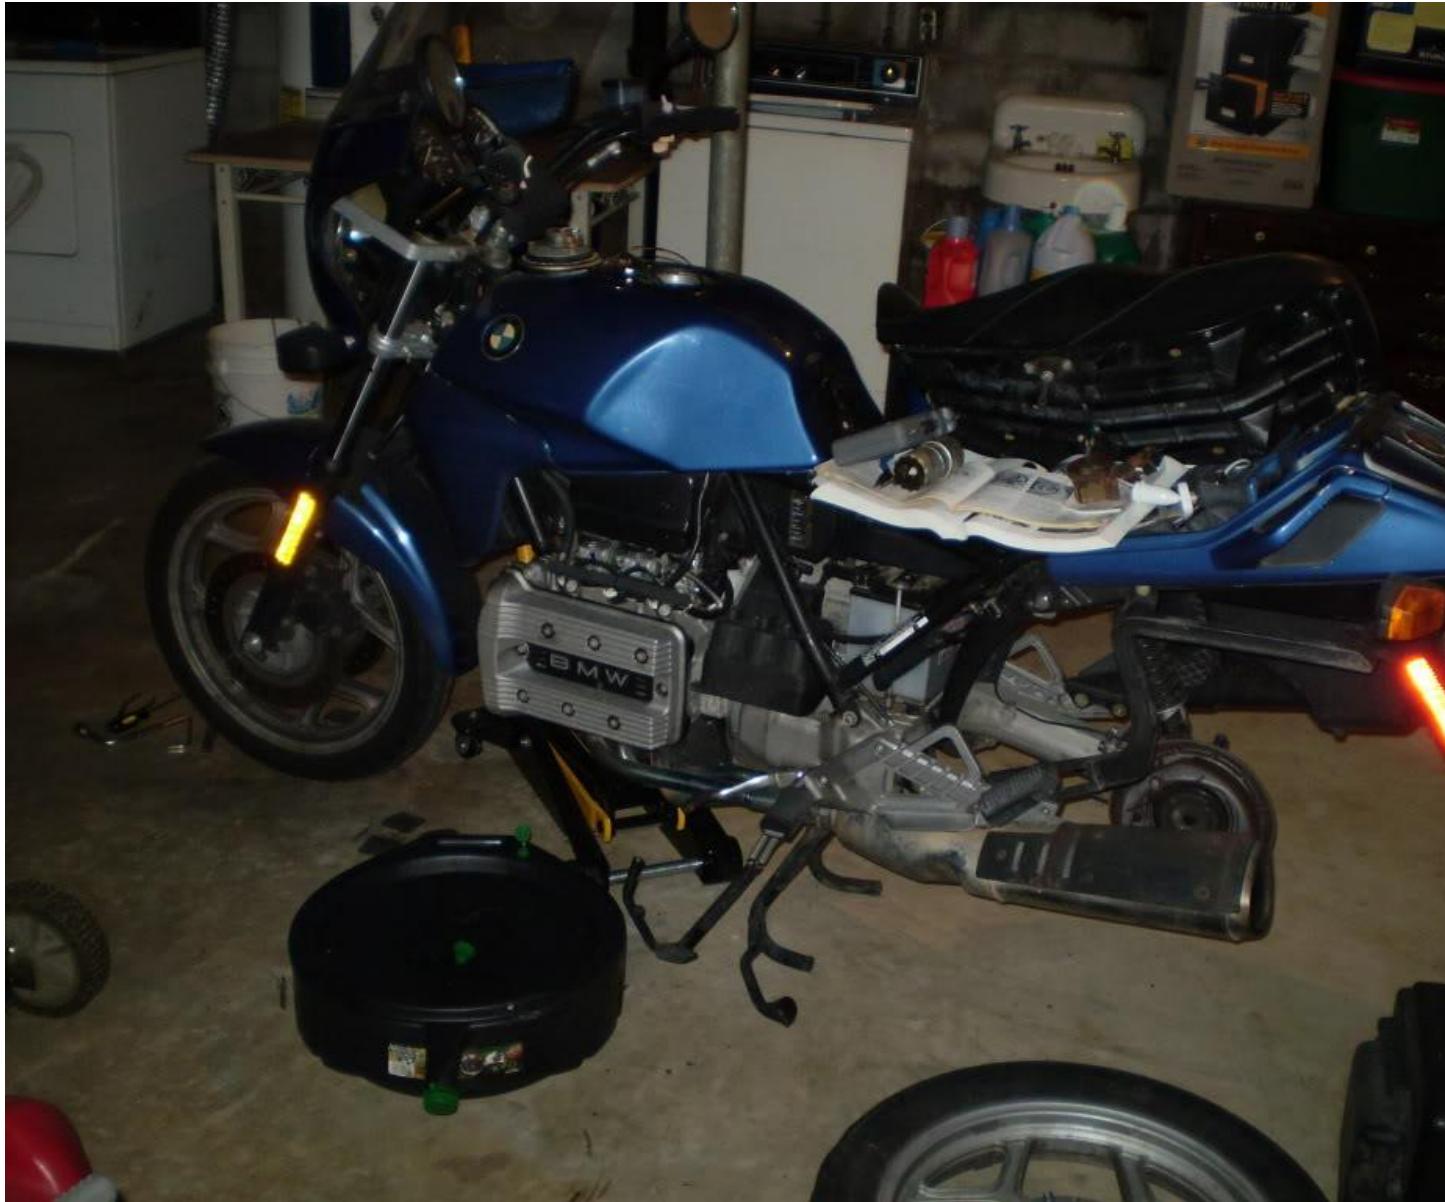
Alright, folks. I've resolved to do a boatload of improvements and repairs to the 1987 K75, including new tires and brakes. Here's how she looks right now, halfway torn apart:

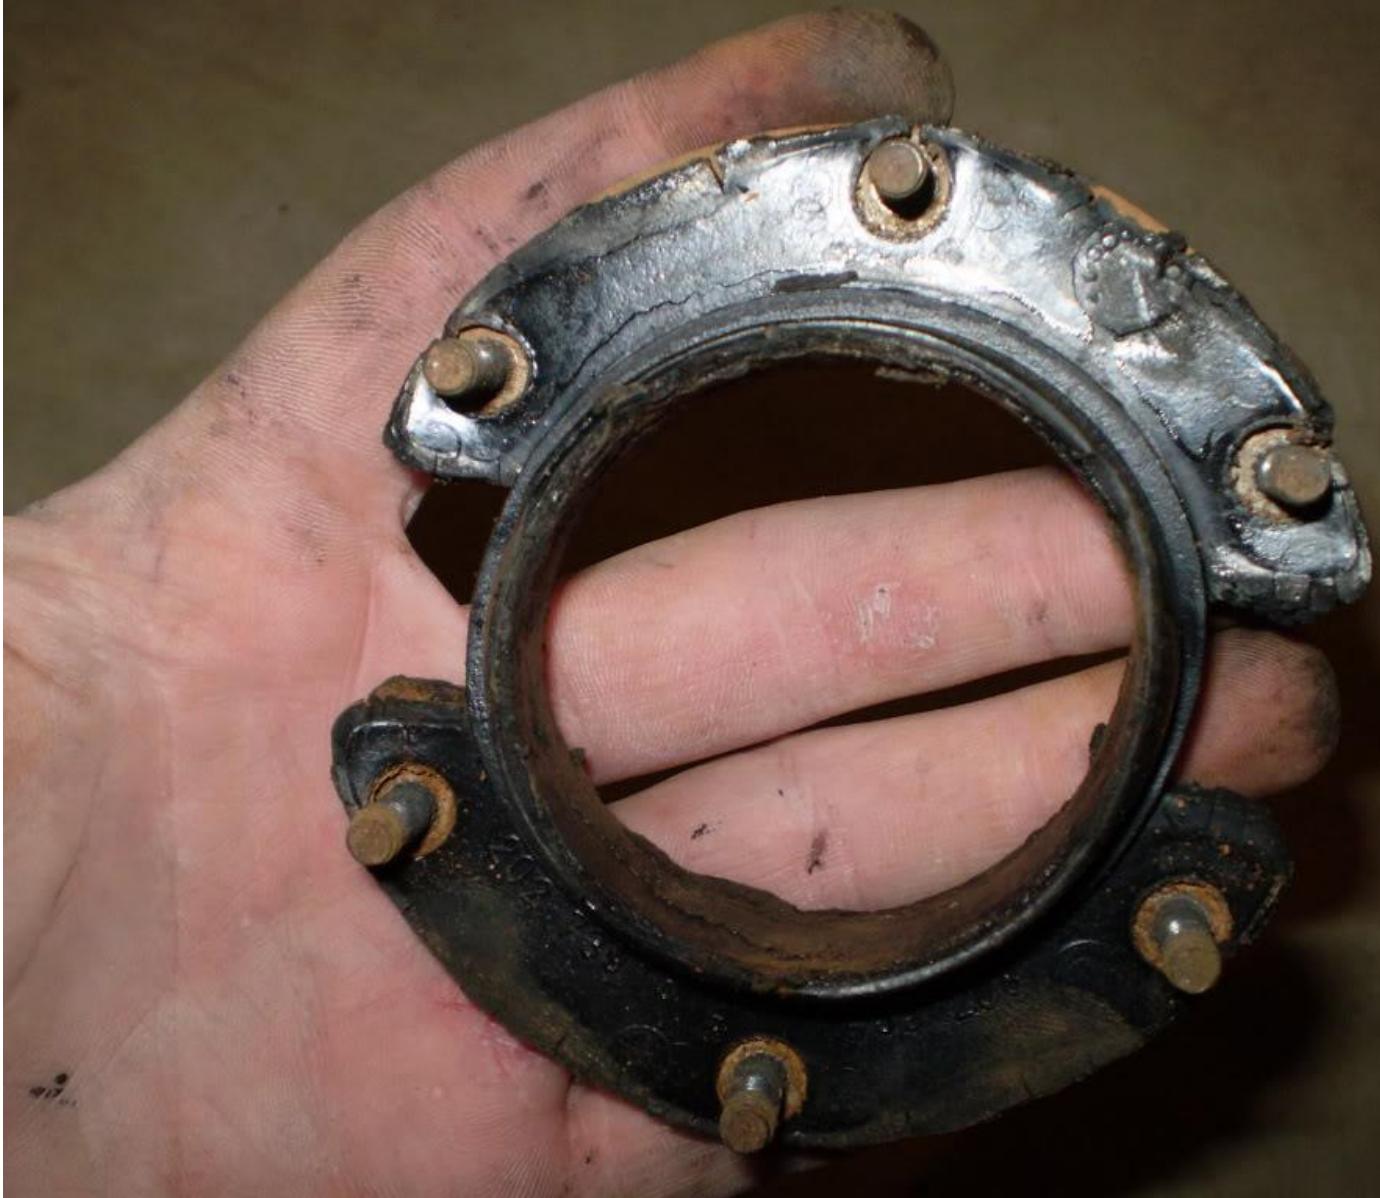
Old:

But before getting into the new brakes and tire replacement, I had a pressing issue: My fuel pump vibration damper was toasted, leaving little grubby, sticky black bits and pieces in the bottom of my fuel tank just waiting to clog up the fuel pump. I had noticed this when I replaced the fuel filter long ago. I figured the old fuel filter had become clogged by the gunk from the slowly dying damper. I wasn't going to let myself ride this summer until I replaced this damper, for fear the little black grubby bits would suddenly ruin my fuel pump and leave me with a much more expensive repair to do. The descriptions of this damper that I've been able to find say it's

I firstly found it curious that my new, \$98 damper (shipping was \$10 from my nearest BMW shop! WTF?) was shaped differently than the original item. Where the original was a circular design with six bolts, the new one had one flat side and one round side, with just five bolts. The numbers stamped on the rubber match the old part numbers, however. Maybe just a strange design evolution over the years?

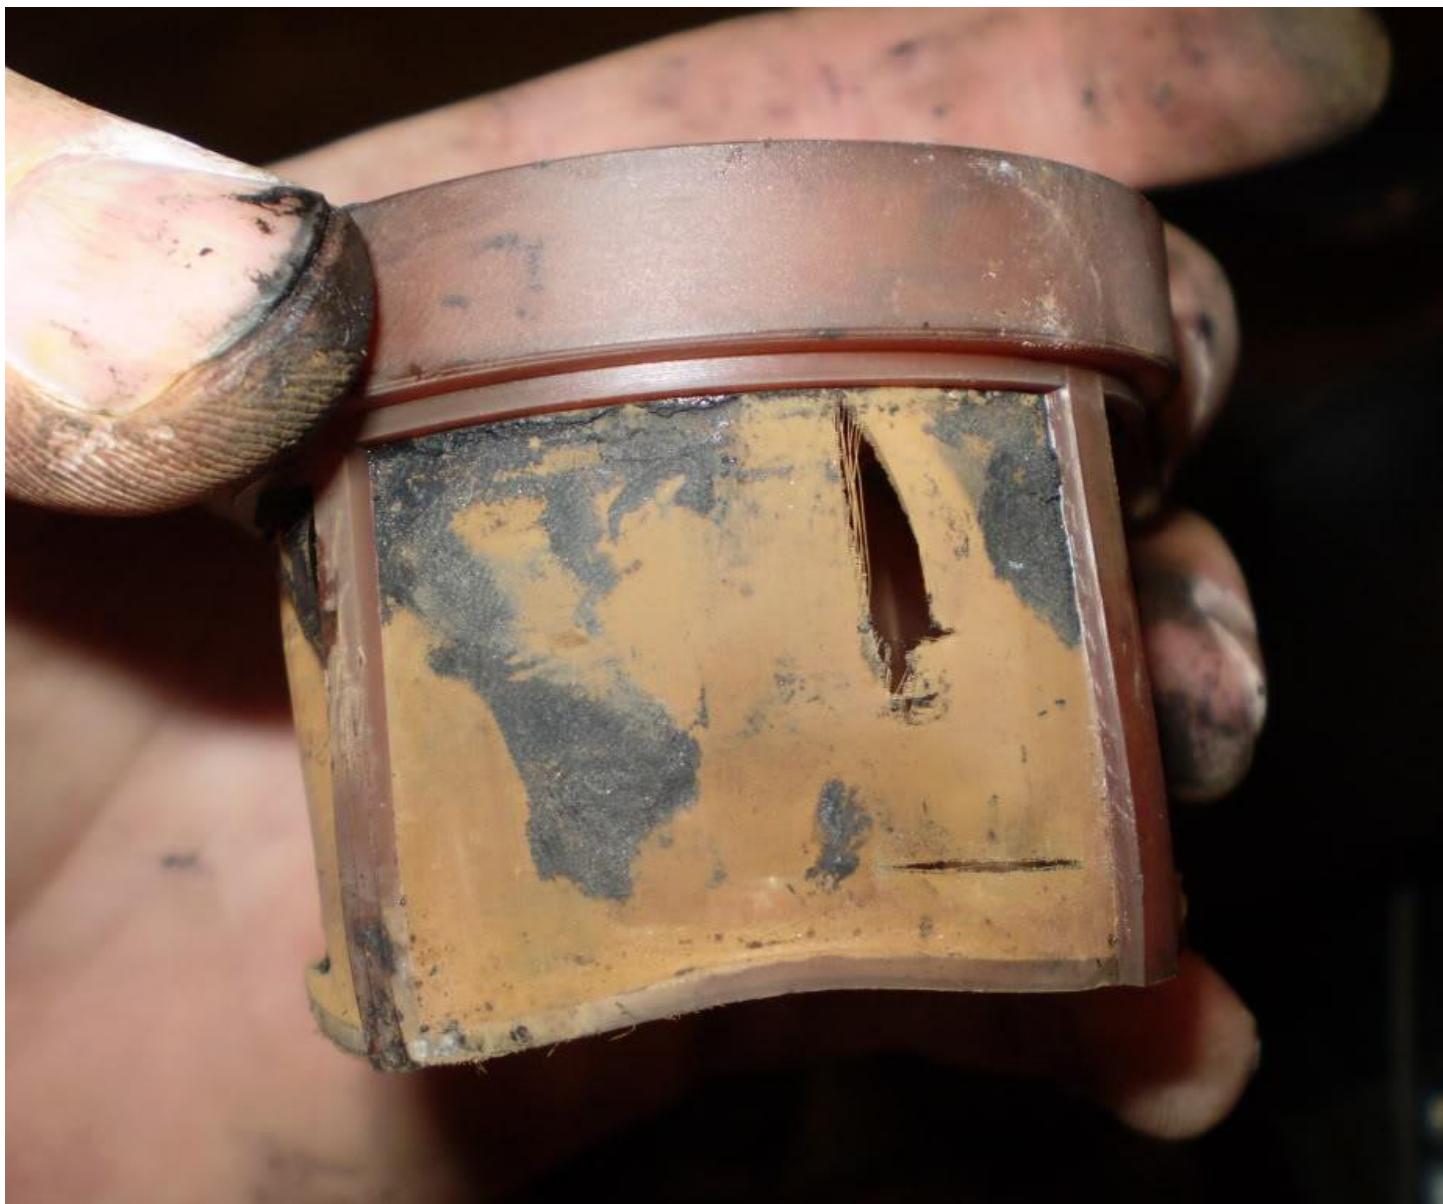
You can see the bits and pieces of nasty black tar-gunk in the fuel pump strainer basket and in the bottom of the tank-- the hole you see is where the fuel pump assembly sits. Until I pulled the pump assembly today, I didn't realize the strainer basket was in such bad shape (note the gunk AND the holes in the woven material), so I still need to call the dealer and order another one.

Basket-- note the torn places:

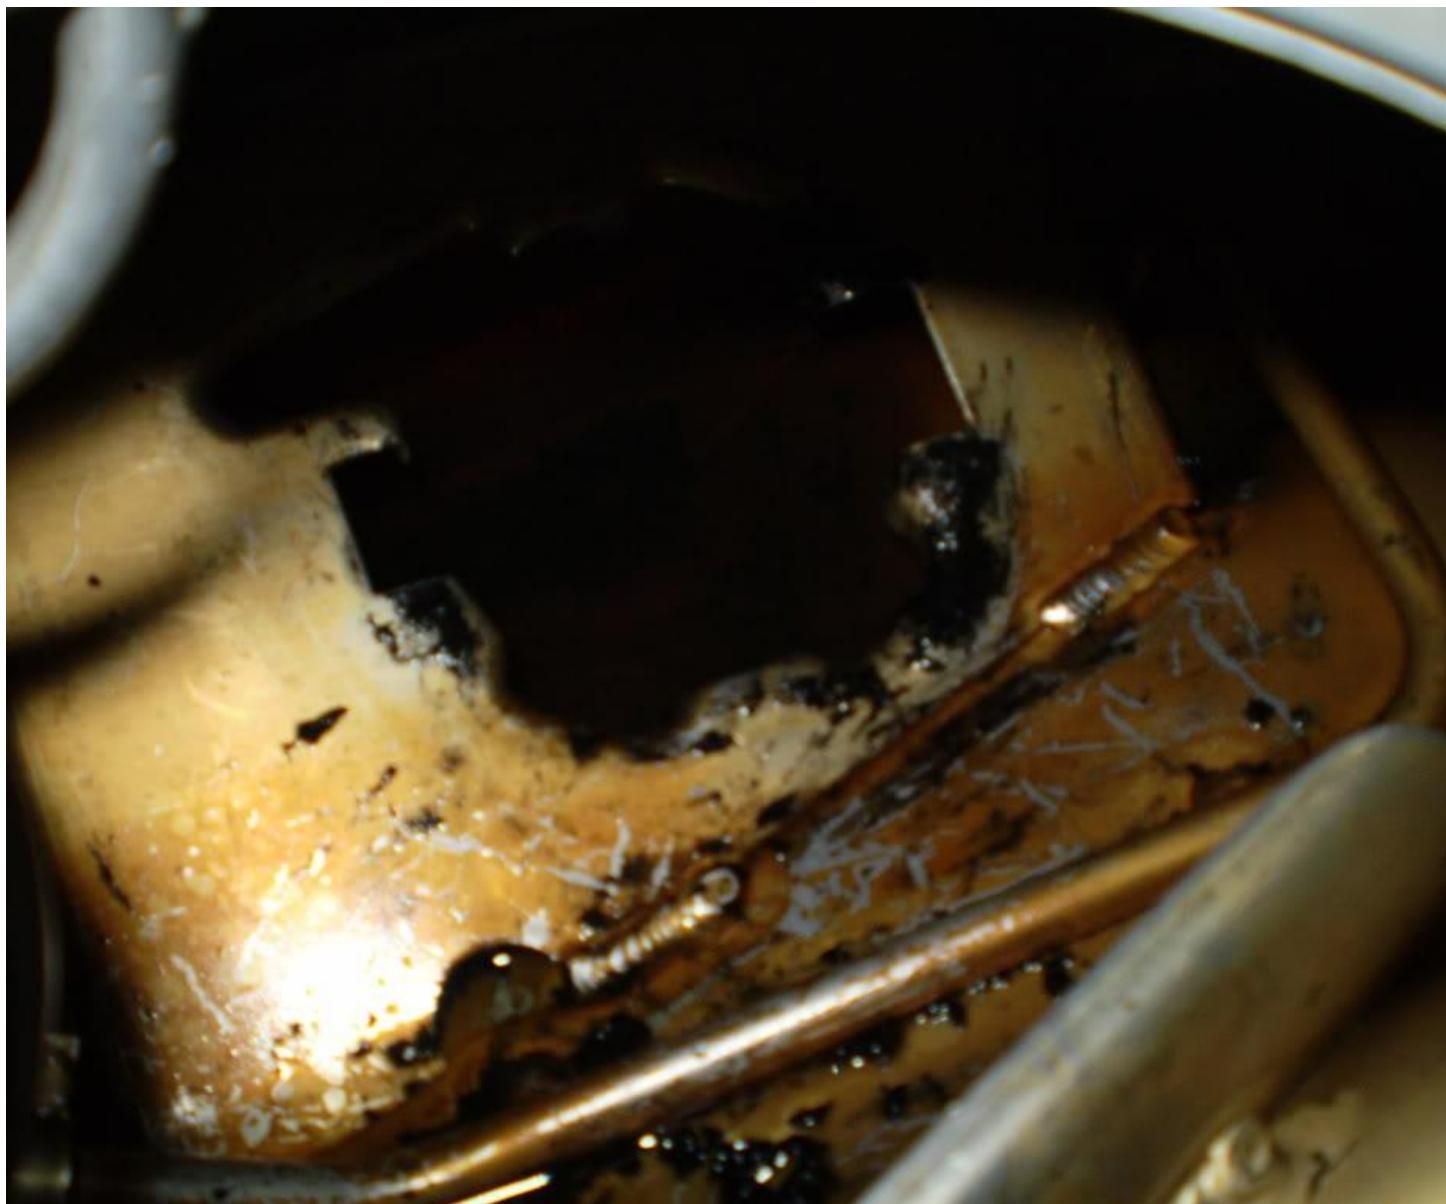
Inside the tank-- this is after I had cleaned out most of the black gunk. This is mostly stains it left behind:

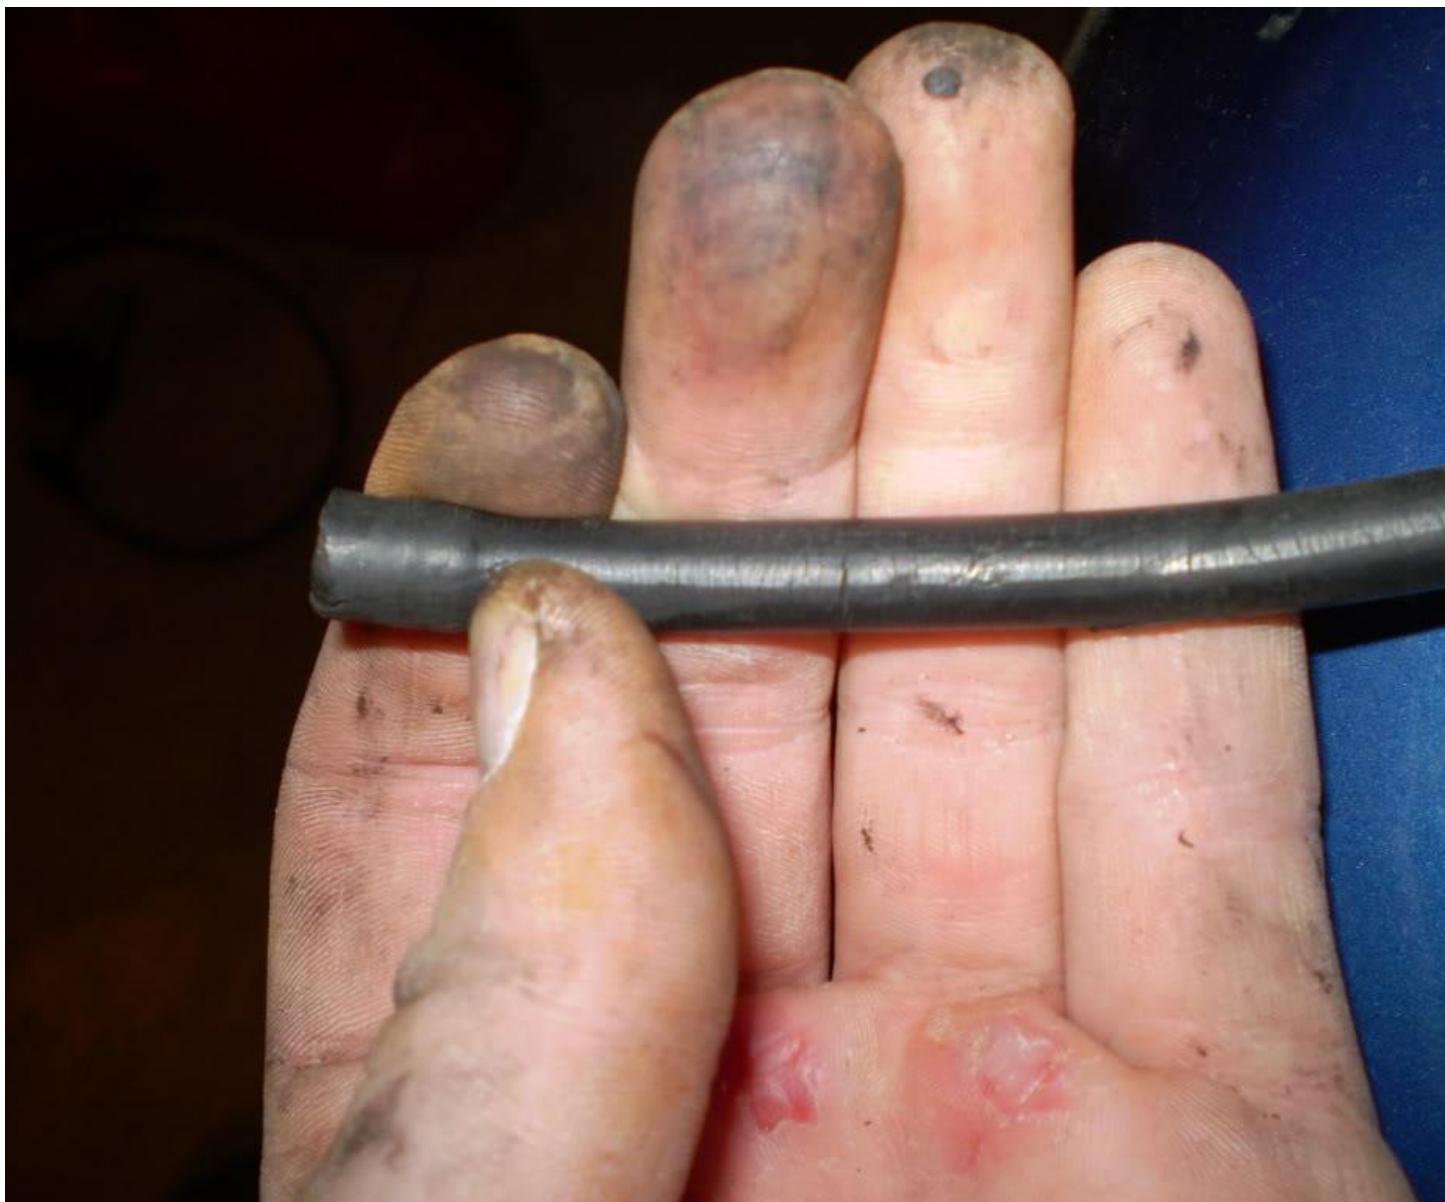
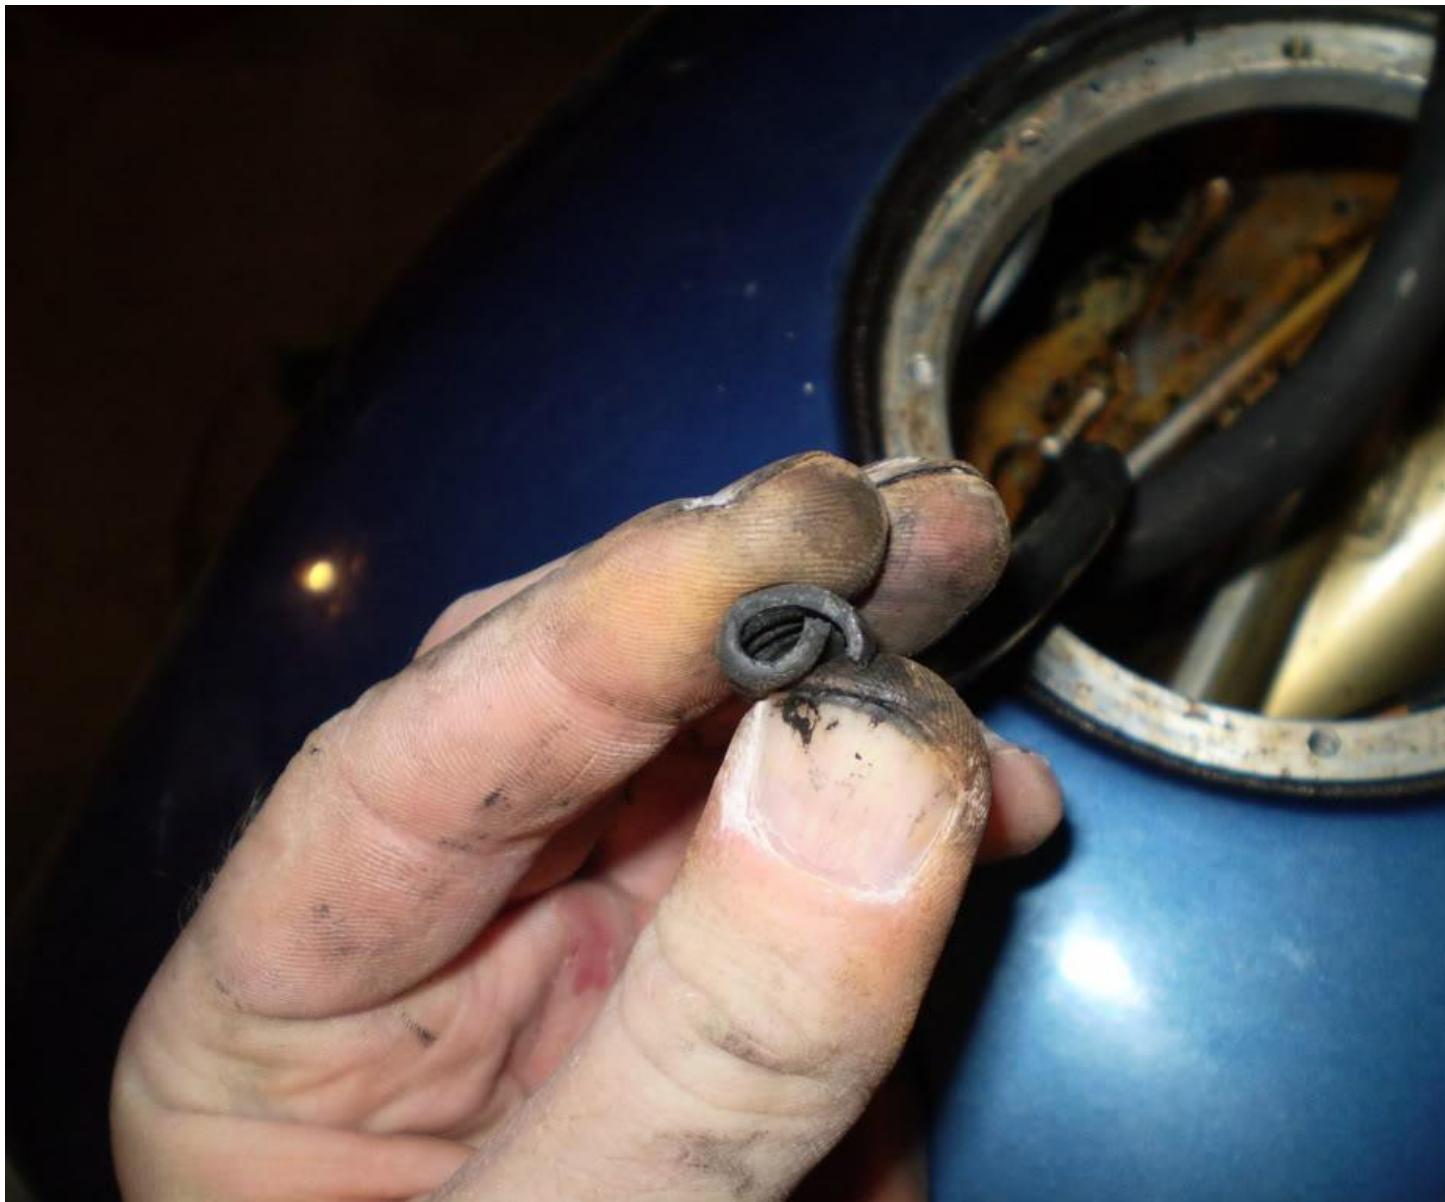
Another thing I need to replace here: the hose that connects to the strainer basket. I guess after nearly 23 years, it's served its purpose:
